Part One

A. Dude Fire Summary

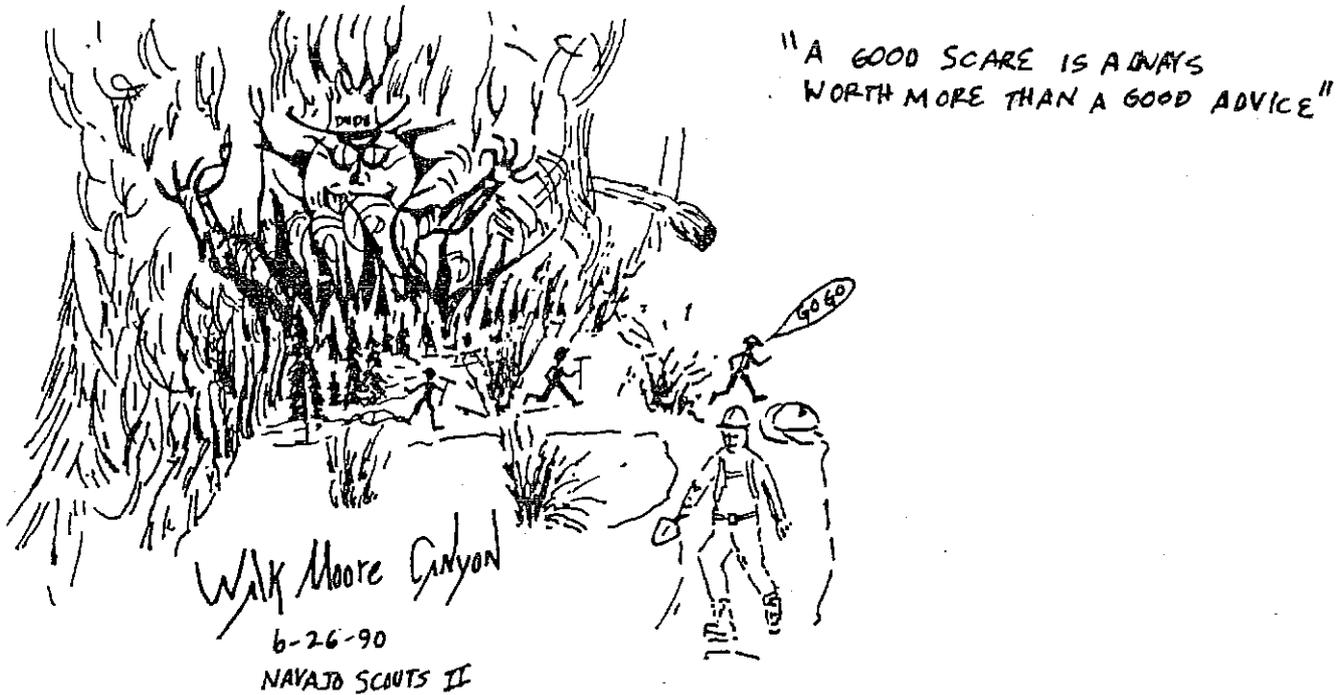
Shortly after Louis Sorrell, Navajo Scouts 2 Crew Boss, had escaped the Dude Fire blow-up, he took a few moments to gather his thoughts and began drawing his impression of the experience on the back of his crew time report book. Other crew members asked if they could contribute to his work. The above illustration (a duplicated rendition) is the result of their efforts – their impression of the Dude Fire, with the accompanying quote: “A good scare is always worth more than good advice.”
